Project Crested Ice. A joint Danish-American report on the crash near Thule Air Base on 21 January 1968 of a B-52 bomber carrying nuclear weapons

Project Crested Ice

A Joint Danish-American Report on the Crash Near
Thule Air Base on 21 January 1968 of a B-52
Bomber Carrying Nuclear Weapons

February, 1970

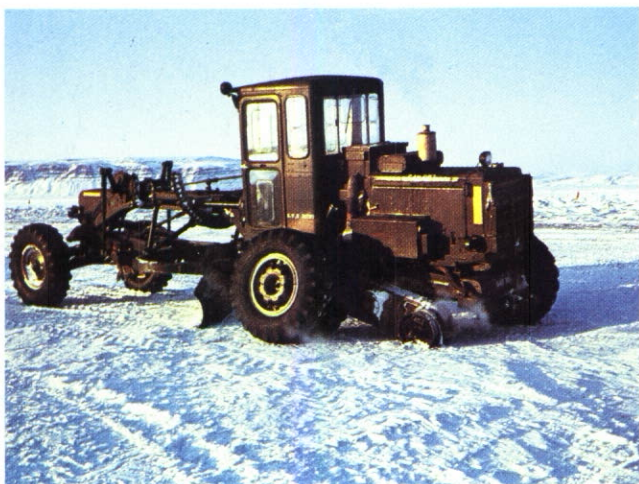
Equipment failure—road grader with broken front axle.

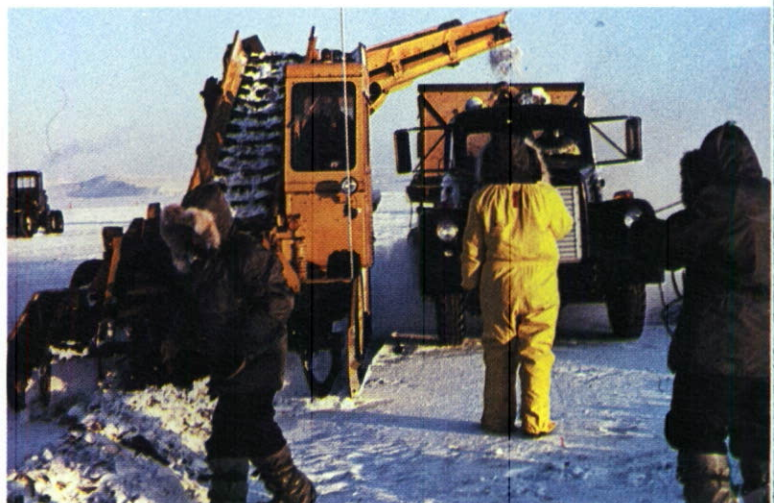
Continuous belt loader filling boxes with contaminated snow and ice.

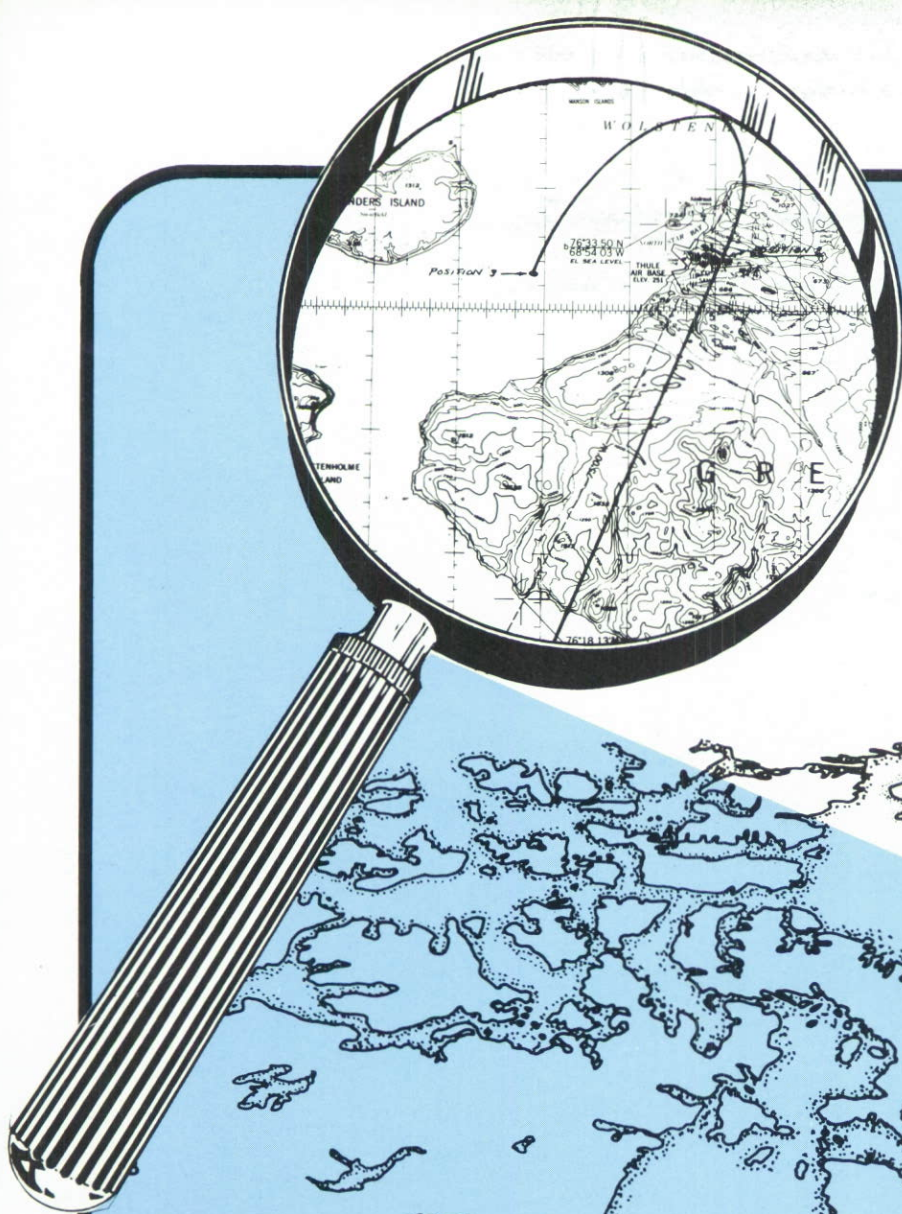
**The crash path
of HOB0 28
prior to impact
on the ice.**

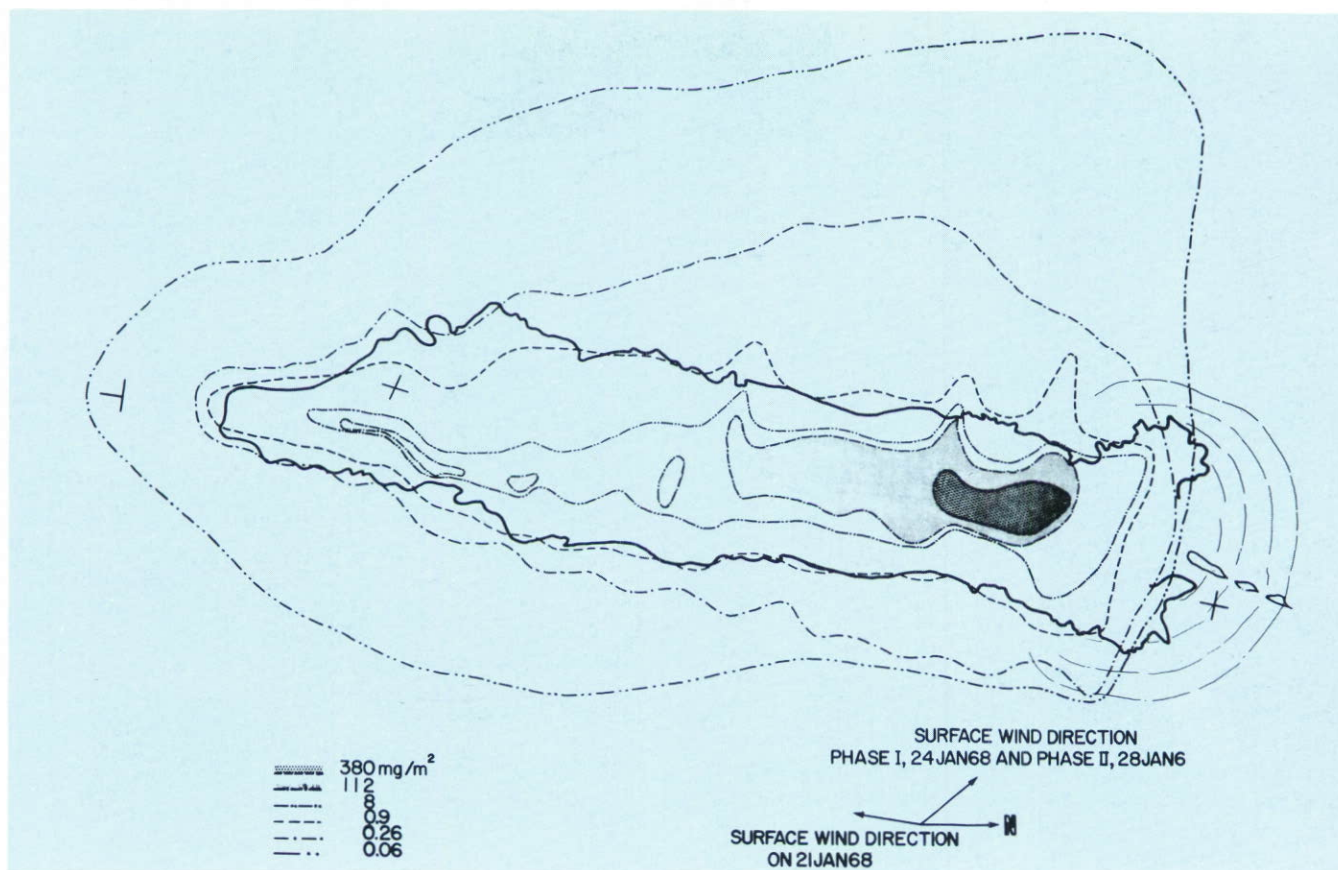
Figure 1 Plutonium contamination levels observed.

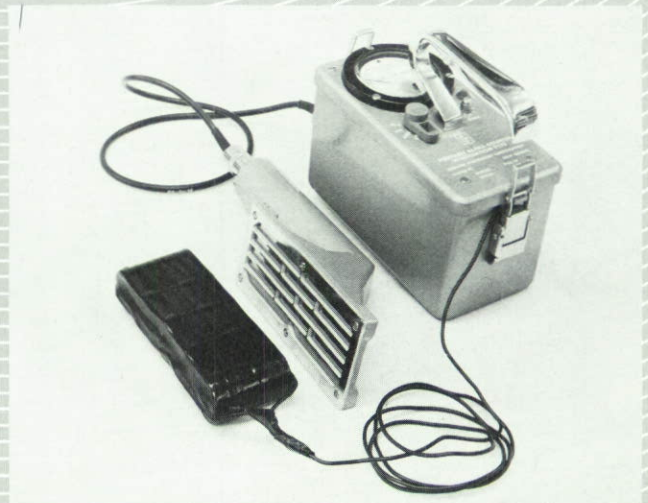
PAC-15 with external battery pack.

Both instruments were operational upon arrival at the crash site but the carbon zinc batteries in the PDR-27 and the mercury batteries in the PAC-1S soon failed in the extreme cold (-30°F). Neither type of battery is rated below 0°F. During the short operational period no beta-gamma radiation was detected with the PDR-27; however, using the PAC-1S, widespread alpha contamination was detected on the surface of the snow, ice, and aircraft debris.

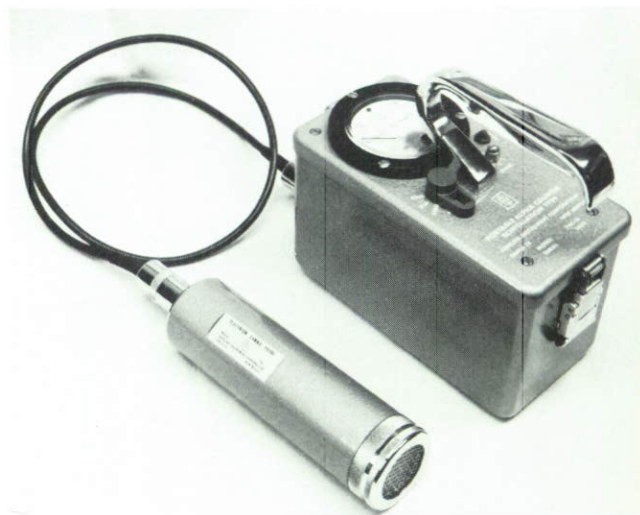
PAC-1S with PG-1.

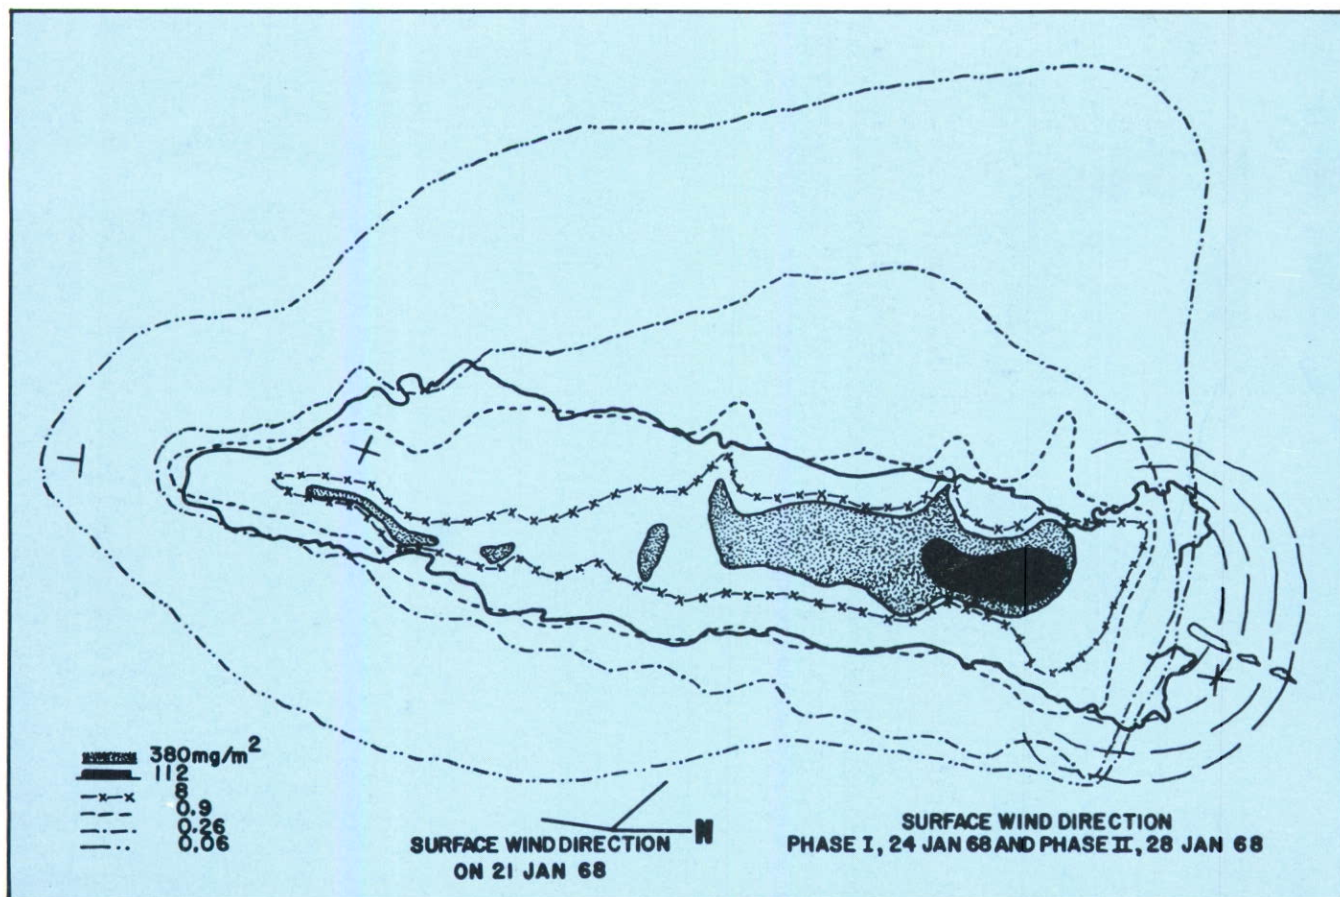
Isocontour map of plutonium contamination.

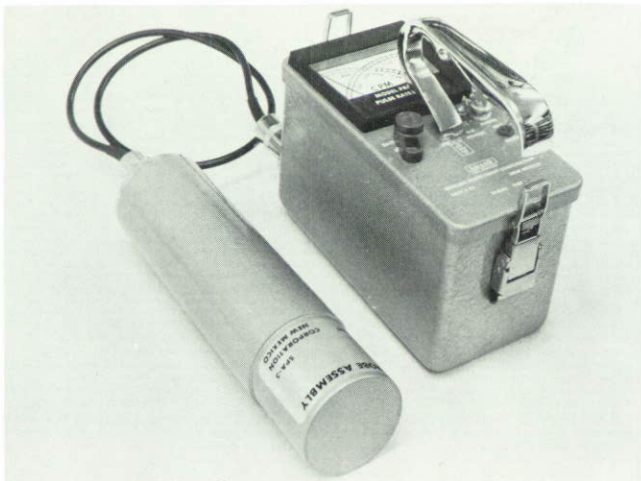
PMR-5 with SPA-3.

Still another application of radiac instrumentation was employed at Thule. The PRM-5 analyzer and the SPA-3 scintillation detector were used in search for weapons components. The SPA-3 detector contains a 2x2-inch NaI(Tl) crystal coupled to a 2-inch photomultiplier tube. This device is particularly suited for detecting 185KEV gamma rays from the uranium 235 used in various weapon components.

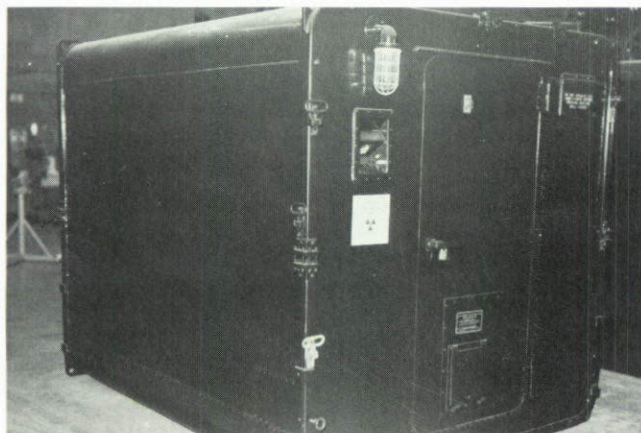
Air-transportable radiac package.

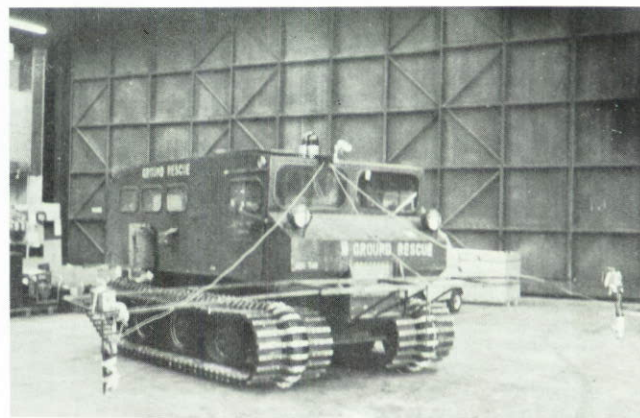
SPA-3 probes on the weasel.

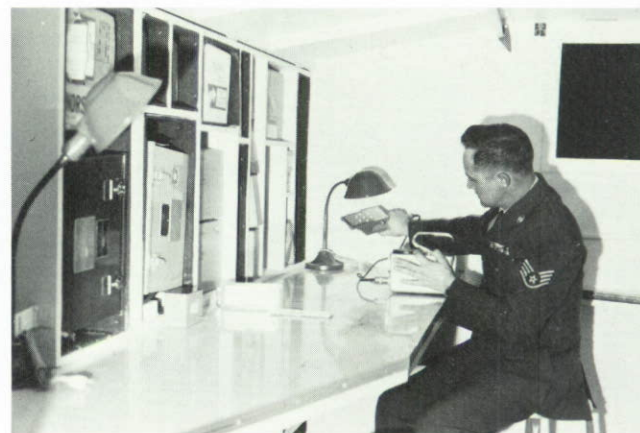
Inside the air-transportable radiac package.

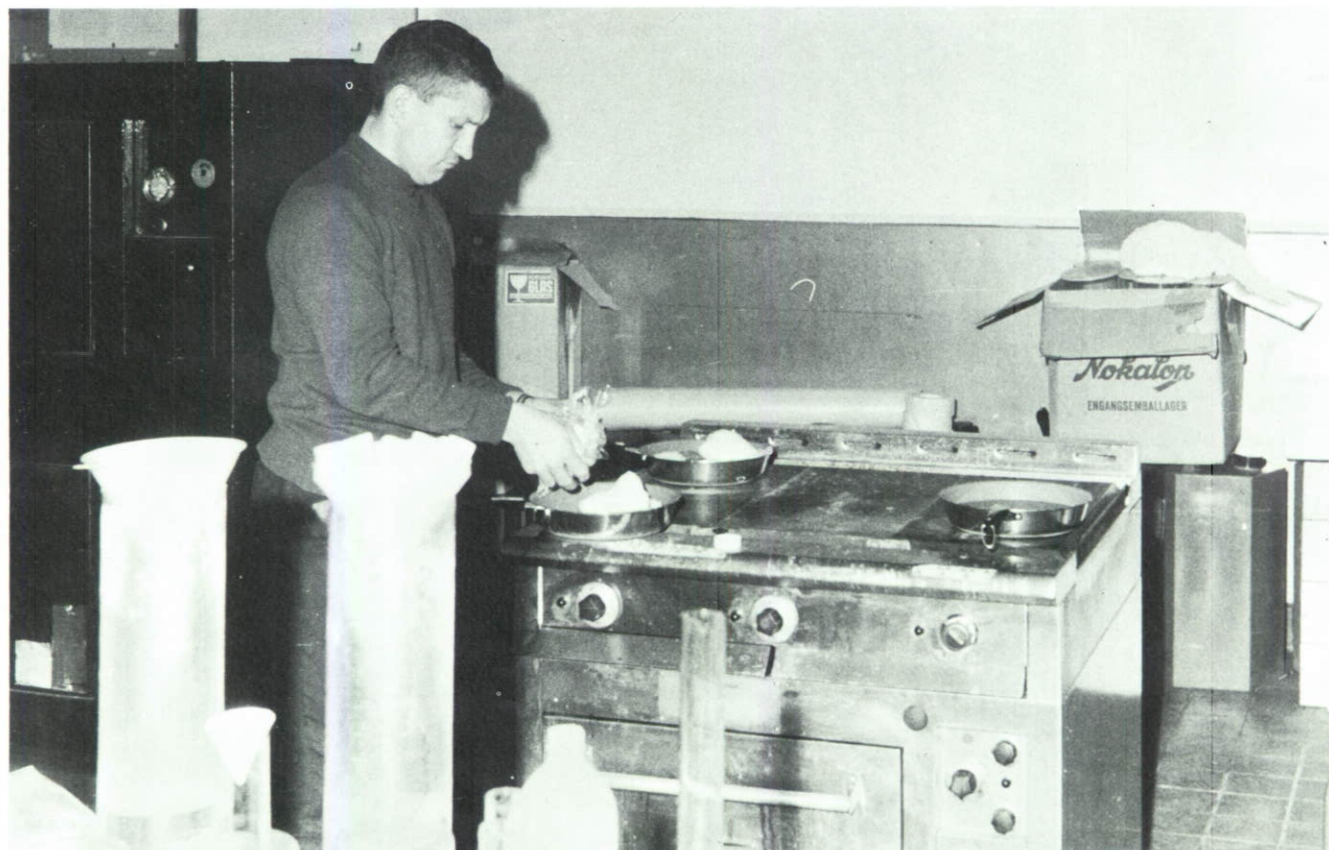
Figure 2. Melting and evaporation of snow samples.

The six snow samples from each location were bulked in the laboratory where they were melted and partially

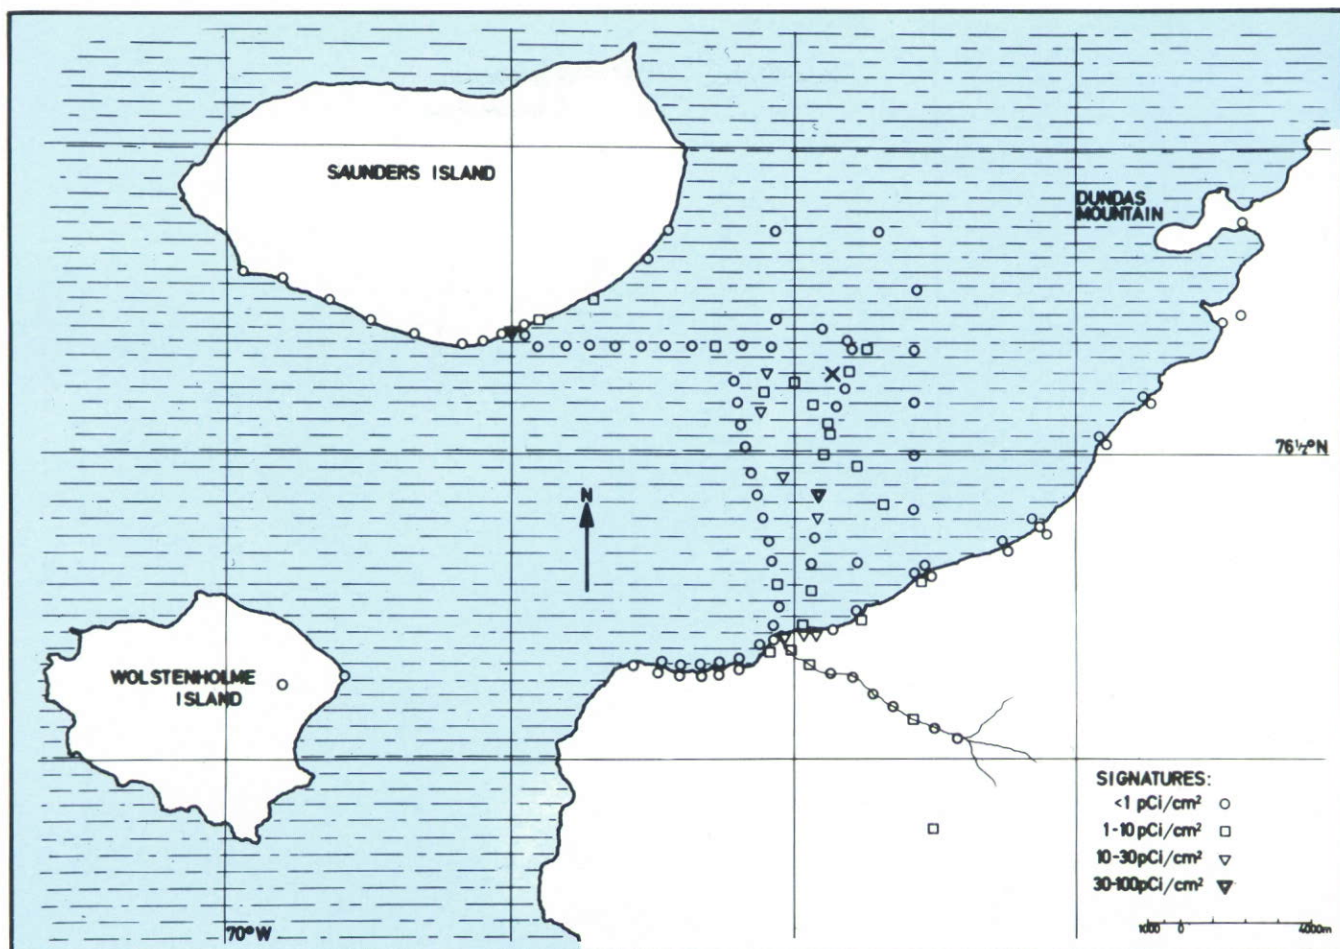
Figure 3. Map of the Bylot Sound area showing plutonium contamination levels. The point of impact is marked with a cross.

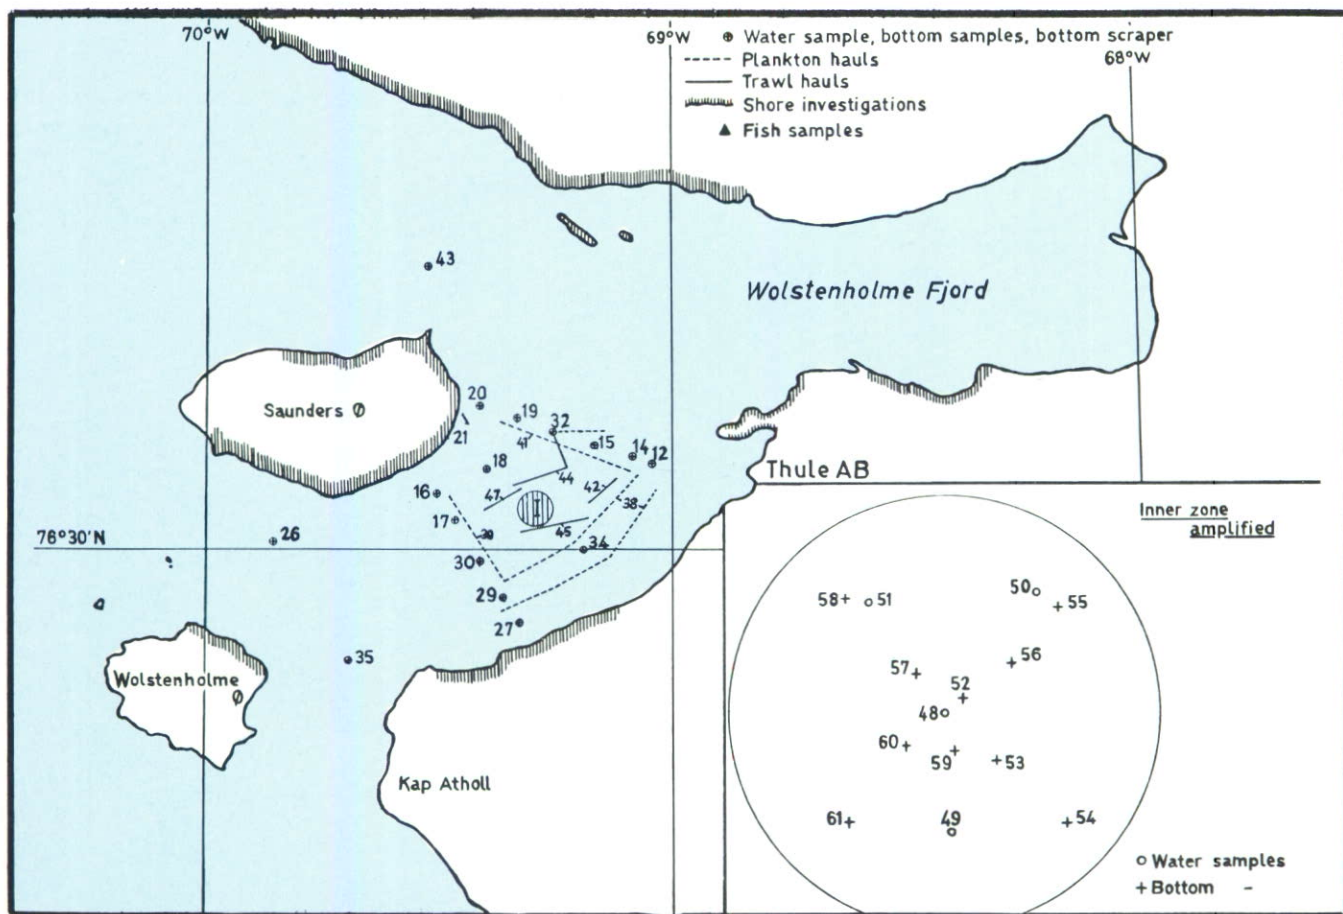
Map showing the sea stations where samples of water, sea bottom, and animals were collected.

- 250 water samples from bottom to surface, collected for hydrographical purposes at 22 stations.
- 4 water samples, each of 100 litres, from Zone 1 (the impact area).
- 14 water samples, each of 50 litres, from Zone 2 (outside the impact area).
- 10 samples of bottom material from Zone 1.
- 10 samples of bottom material with animals, including bivalves, from Zone 1.
- 14 samples of bottom material from Zone 2.
- 25 dredge hauls for bottom animals at 14 stations in Zone 2.
- 6 trawl hauls for *Crustacea* and fish in Zone 2.

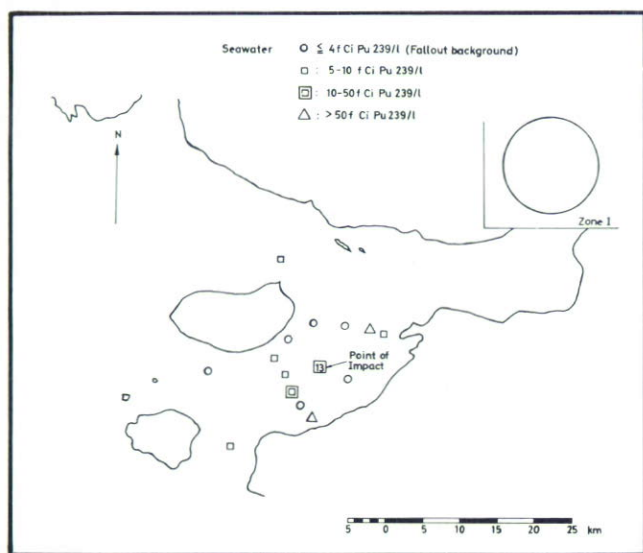
Figure 6 Pu 239 levels in seawater. Thirteen samples were collected in zone I.

- *Sea water.* In Figure 6 the results of the sea-water analysis are shown. The maximum for water samples was 76 fCi Pu 239/litre found in a sample collected approximately 5 km west of Dundas Mountain. The median fallout background in seawater from five Greenland locations far away from Thule (Danmarkshavn, Angmagssalik, Prins Christians Sund, Godthåb, and Godhavn) was 4 fCi Pu 239/litre as compared with the median level found at Thule: 5 fCi Pu 239/litre. At Qanaq, approximately 100 km north of Thule, the level was 3 fCi Pu 239/litre. In Zone I the seawater samples were collected both at the surface and at the bottom.

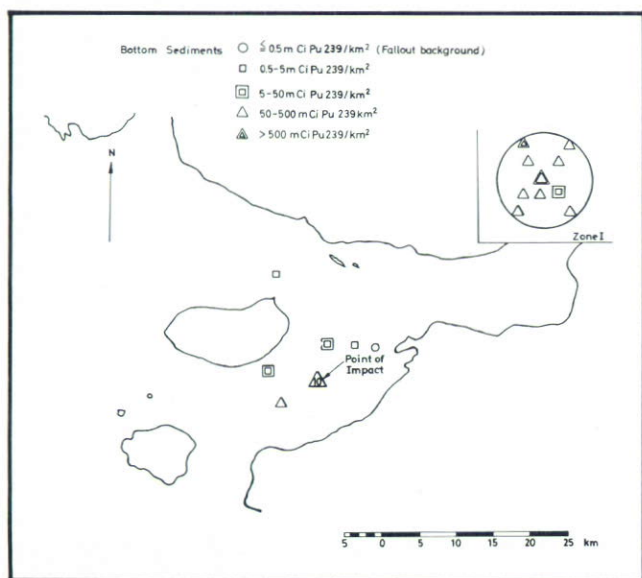
Figure 7 Pu 239 levels in bottom sediments. Ten samples were collected in zone I.

It is concluded that the accident caused only a slight

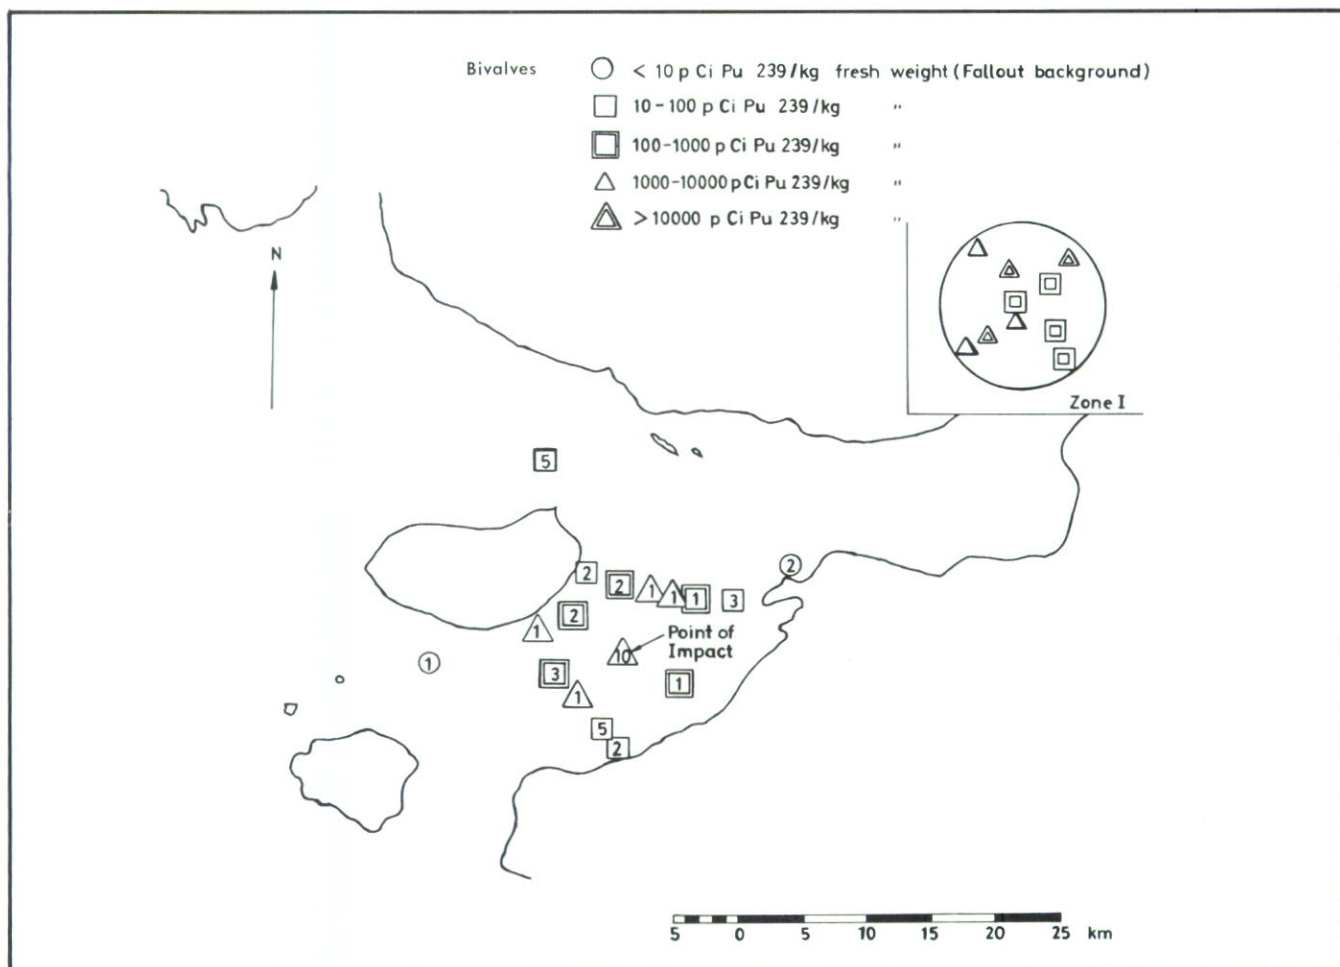
Figure 8 Pu 239 levels in bivalves. The numbers refer to the number of samples analyzed from each location.

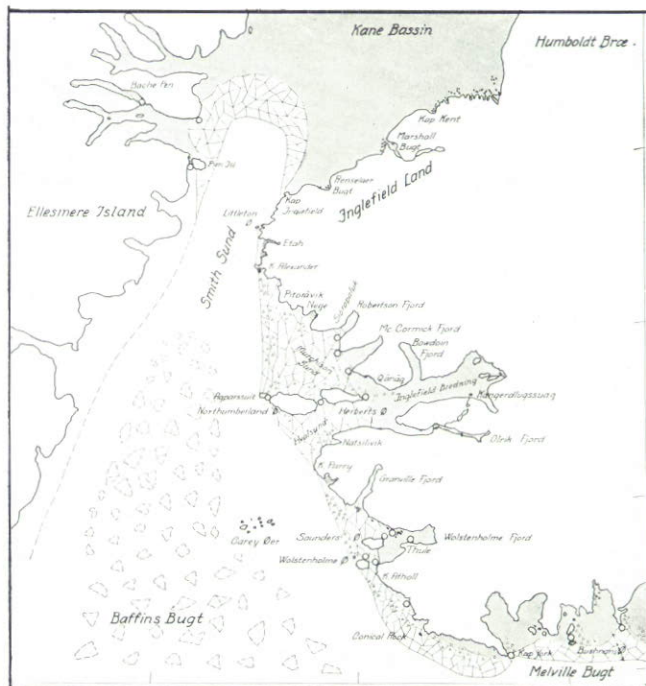
Figure 1. Ice conditions north of Baffin Bay. (Old Map)

ice cover is normally not very thick and rarely exceeds depth of 1 meter (39 inches), whereas much thicker ice can be found in North Star Bay and Wolstenholme Fjord.

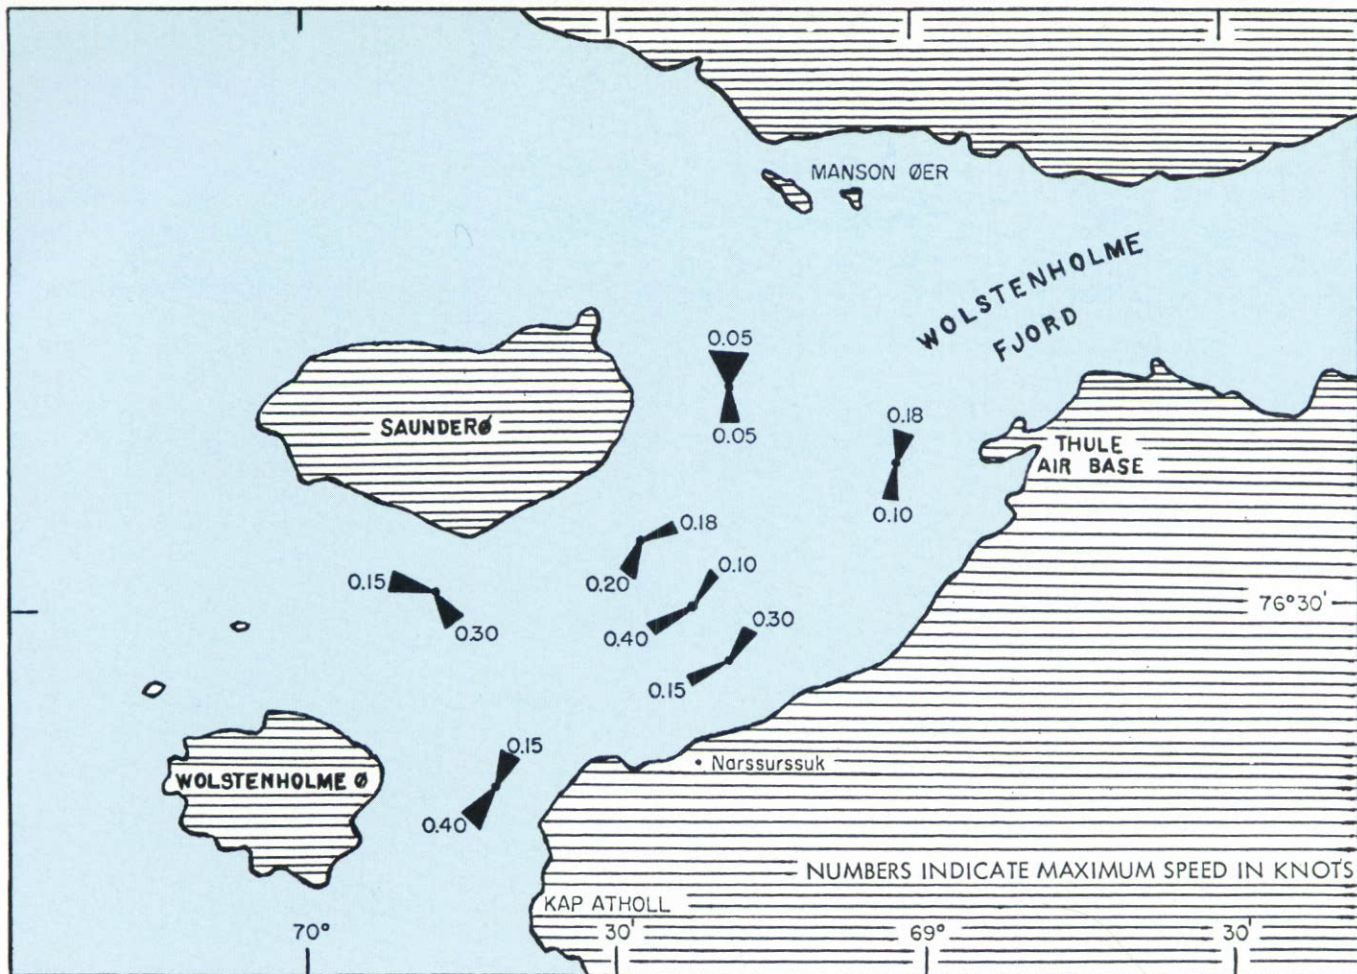
Figure 2. Summary of current data.
