Project Crested Ice. A joint Danish-American report on the crash near Thule Air Base on 21 January 1968 of a B-52 bomber carrying nuclear weapons

Project Crested Ice

A Joint Danish-American Report on the Crash Near
Thule Air Base on 21 January 1968 of a B-52
Bomber Carrying Nuclear Weapons

February, 1970

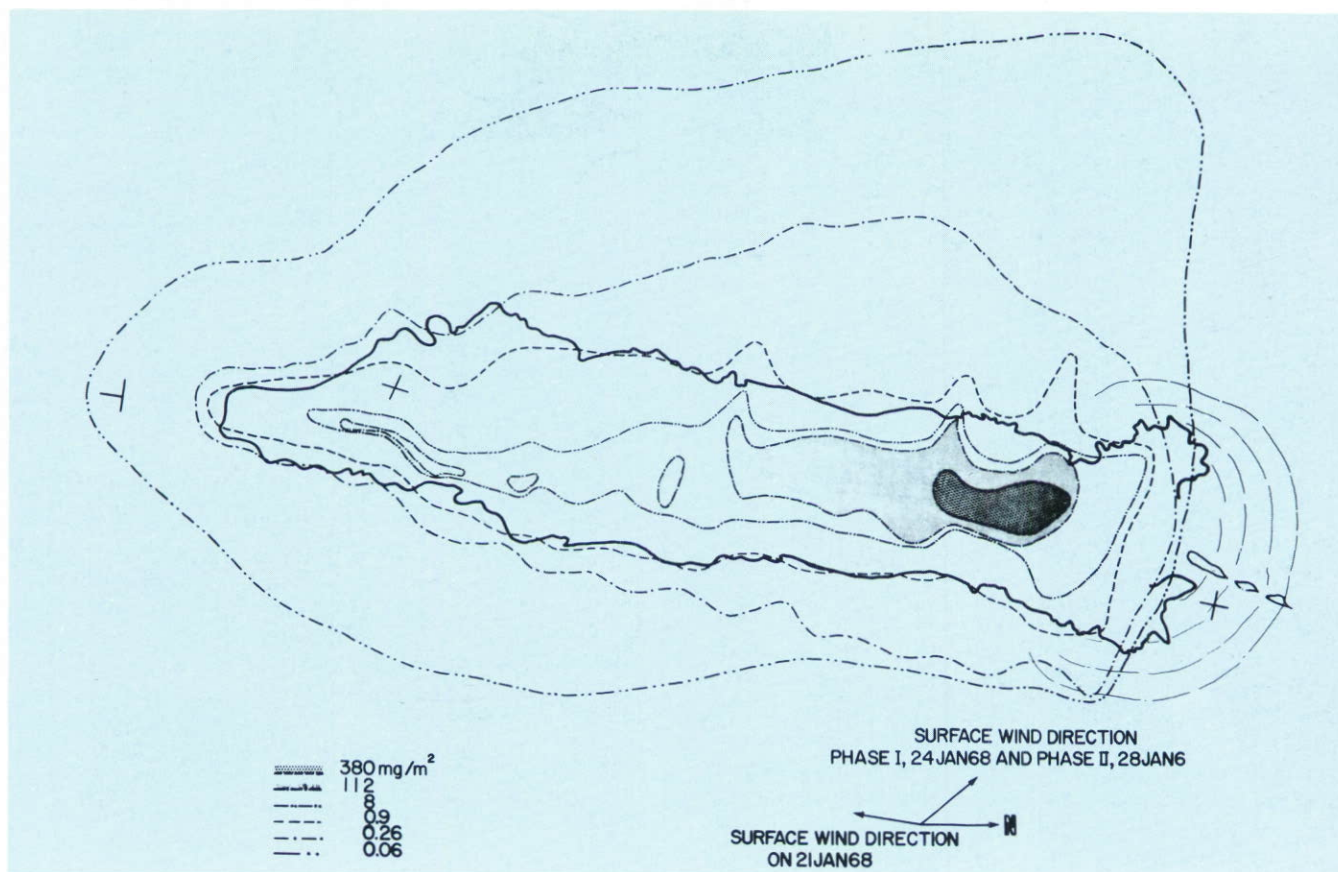
Figure 1 Plutonium contamination levels observed.

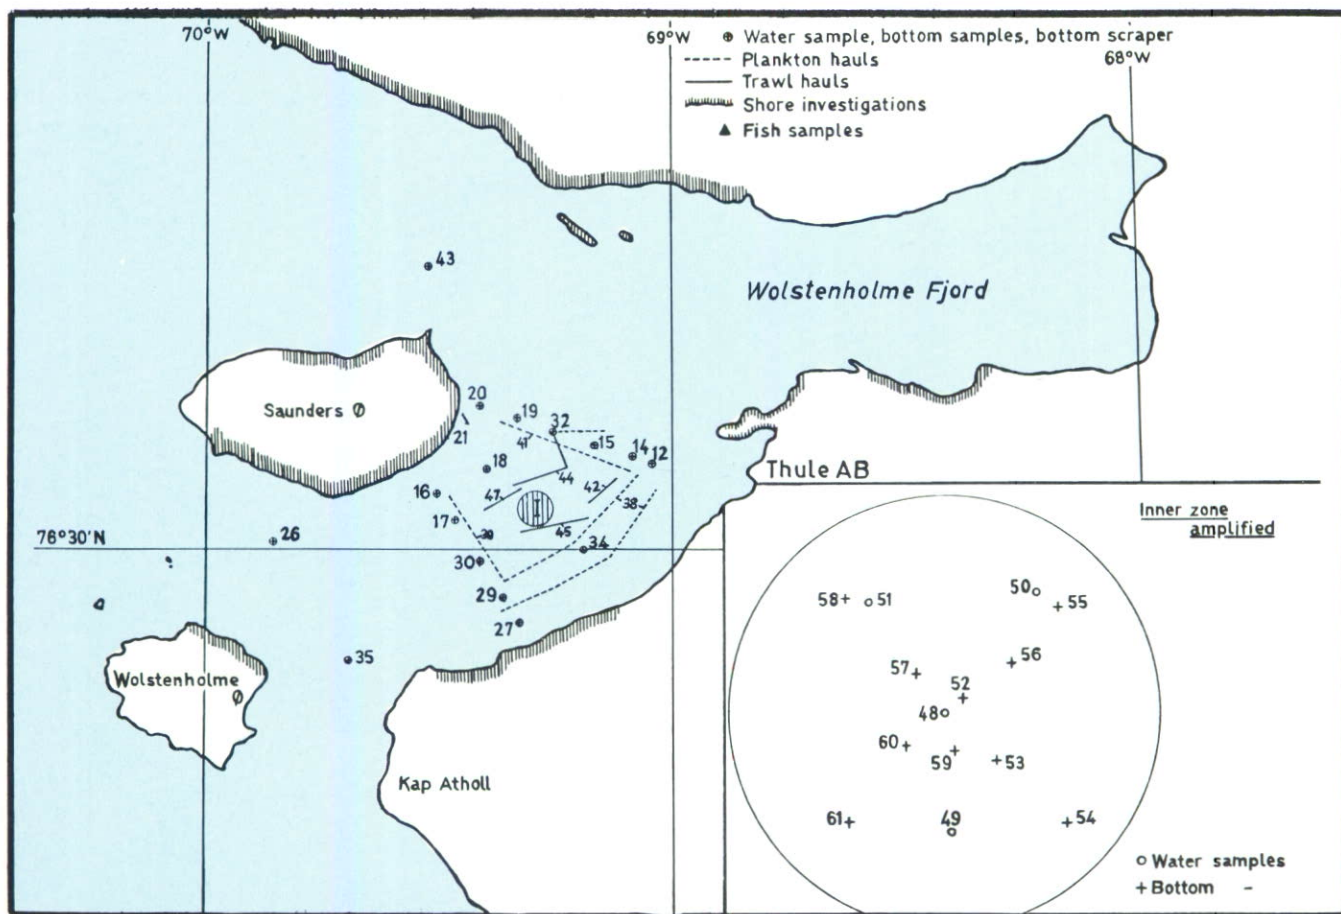
Map showing the sea stations where samples of water, sea bottom, and animals were collected.

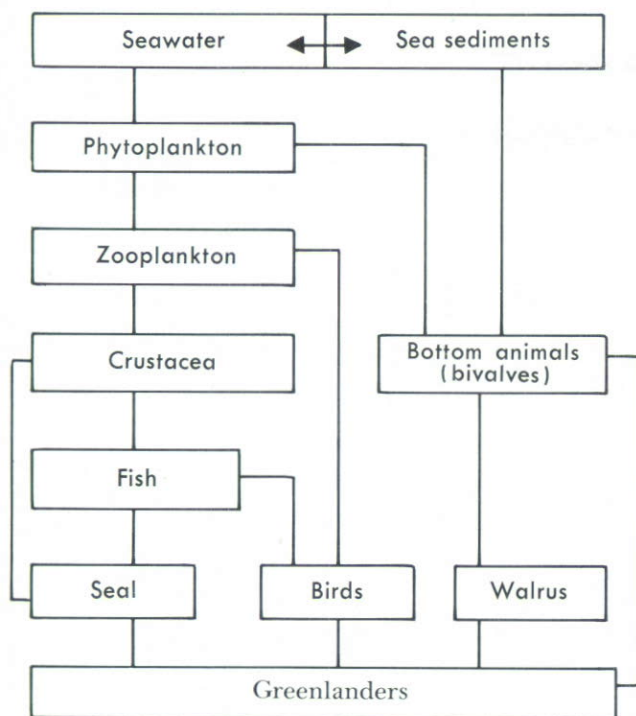
Figure 1 Food chains in an arctic, marine environment.

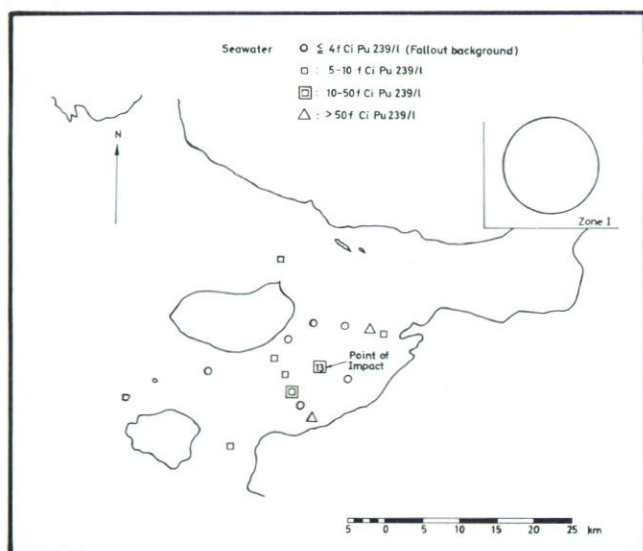
- *Sea water.* In Figure 6 the results of the sea-water analysis are shown. The maximum for water samples was 76 fCi Pu 239/litre found in a sample collected approximately 5 km west of Dundas Mountain. The median fallout background in seawater from five Greenland locations far away from Thule (Danmarkshavn, Angmagssalik, Prins Christians Sund, Godthåb, and Godhavn) was 4 fCi Pu 239/litre as compared with the median level found at Thule: 5 fCi Pu 239/litre. At Qanaq, approximately 100 km north of Thule, the level was 3 fCi Pu 239/litre. In Zone I the seawater samples were collected both at the surface and at the bottom.

Figure 6 Pu 239 levels in seawater. Thirteen samples were collected in zone I.

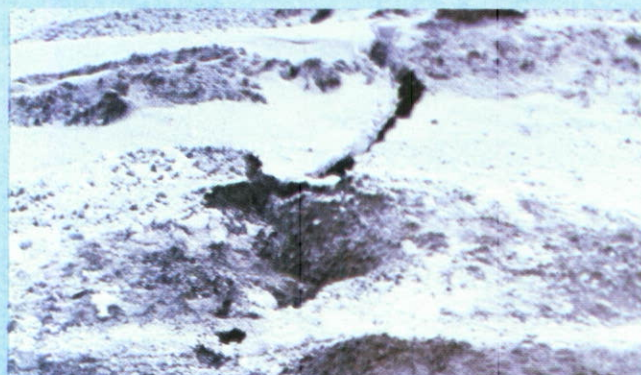
Crack in the ice.

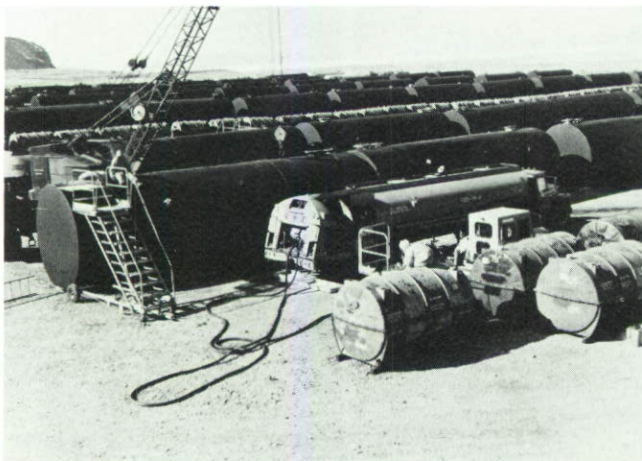
TANK FARM. Pump-transfer crews prepared to pump melted snow water from the large 25,000-gallon tank to small containers to facilitate shipping the residue to the U.S.

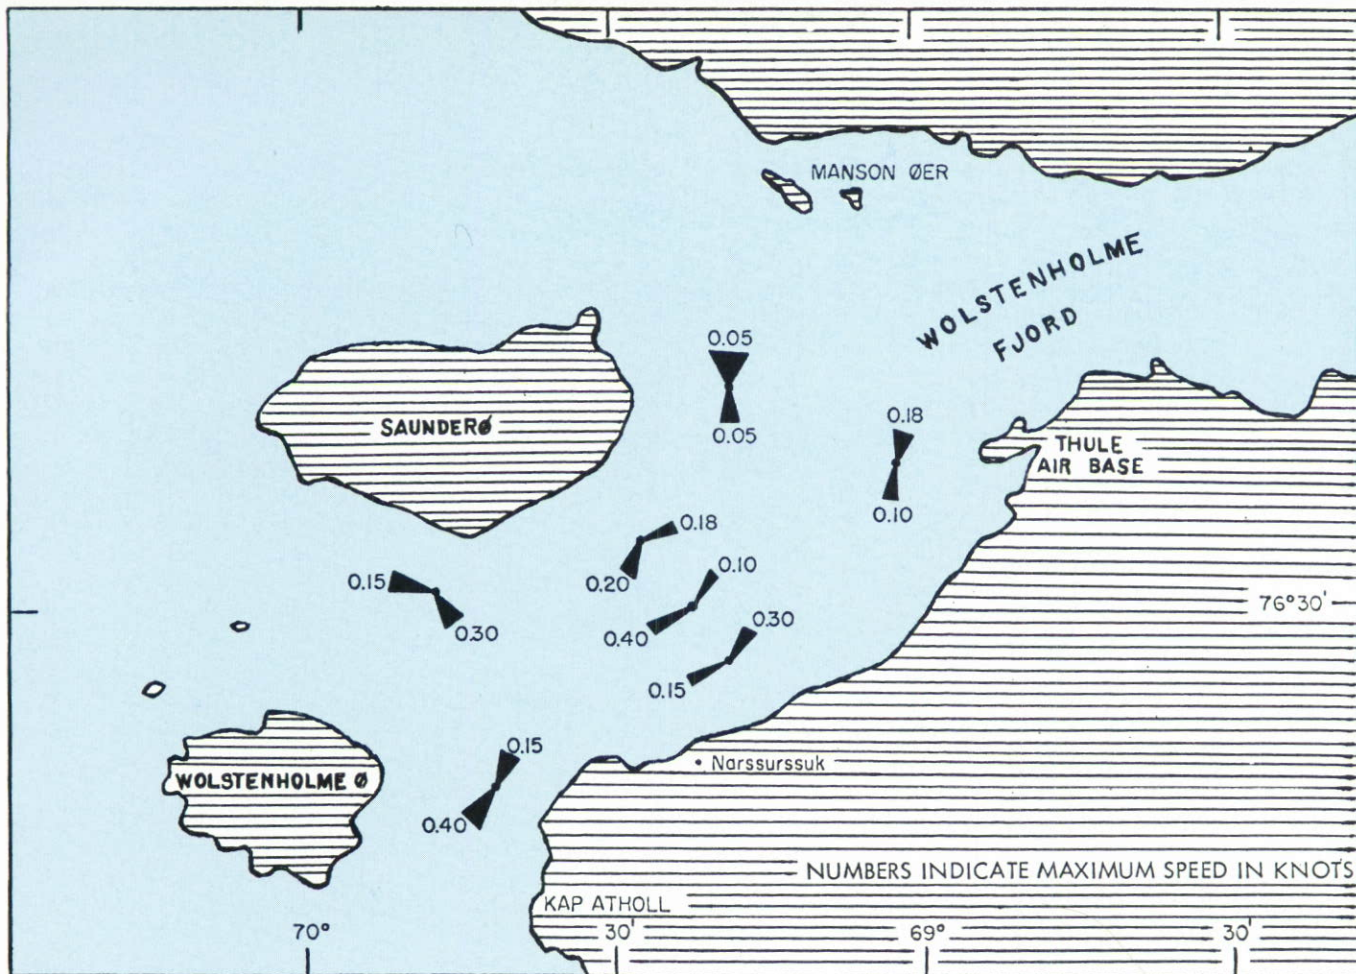
Figure 2. Summary of current data.

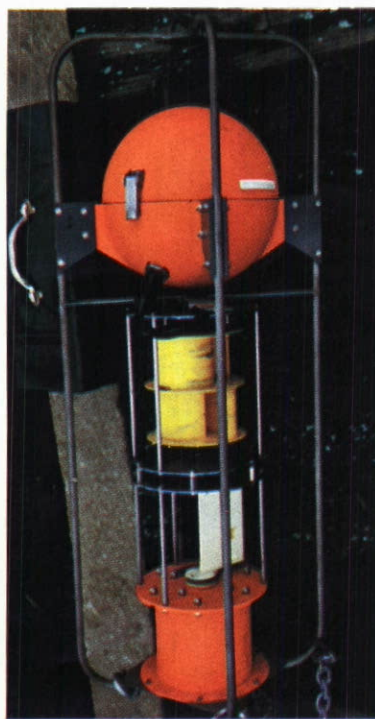
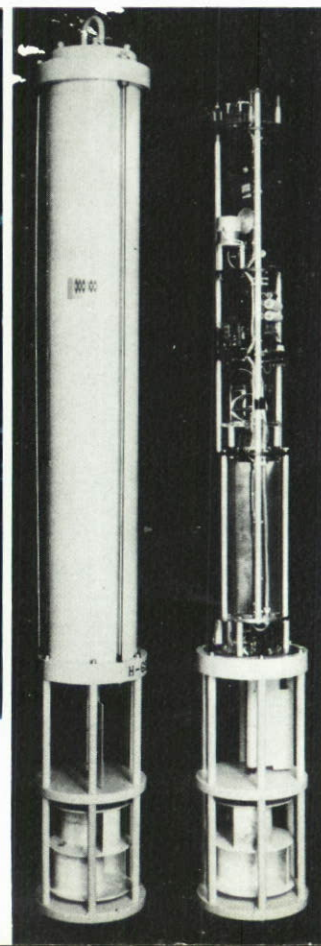
Geodyne Current Meter.
