New Concept for Museum Storage Buildings – Evaluation of Building Performance Model for Simulation of Storage

2016 International Conference on Architecture and Civil Engineering.

New Concept for Museum Storage Buildings

Evaluation of Building Performance Model for Simulation of Storage

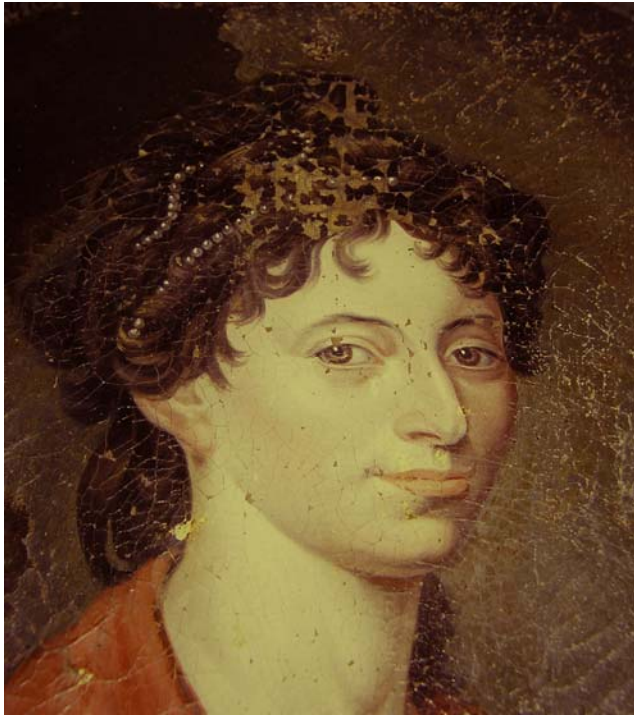
Figure 4. Portrait of Danish Queen Marie of Hessen-Kassel. The paint layers are seriously damaged due to very humid conditions. Small flakes of paint are missing especially in the hair. The paint layers and the canvas of the paint react differently on changes in the relative humidity.. (Photo: Anette Aalling)

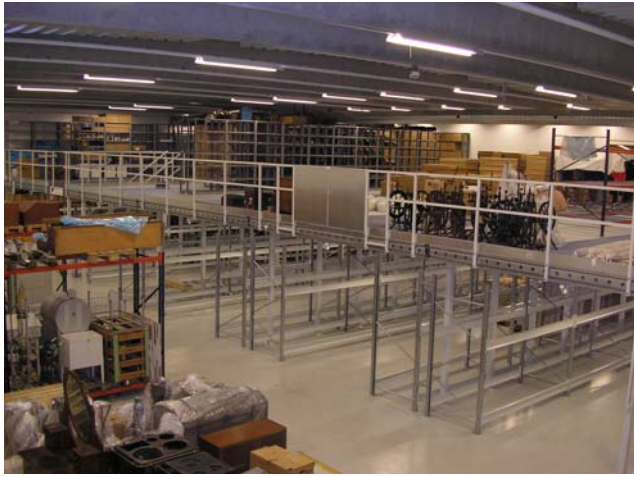
Figure 6. Picture of the interior of the museum storage showing the mezzanine construction (Photo Centre for Preservation of Cultural Heritage).

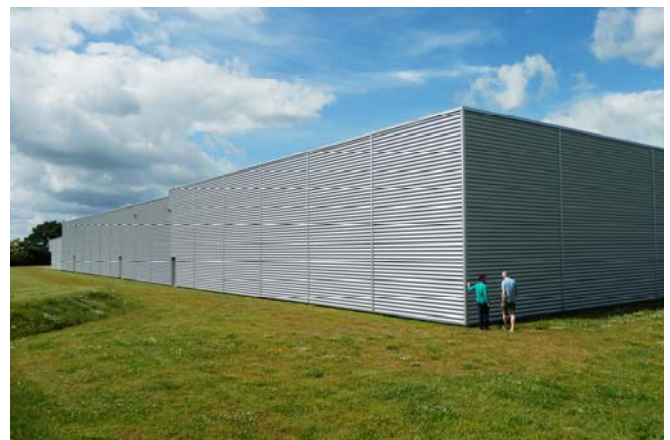
Figure 8. Exterior view on the storage building after completion. Old to the left and New to the right (Photo Christensen).

thickness of the roof and not the floor construction. In Fig. 8 the exterior view on the old and new storage building are shown after completion.
