## Testing Joints of Air and Vapour Barriers, Do We Use Relevant Testing Methods?

Møller, Eva B.; Rasmussen, Torben V.

Current Topics and Trends on Durability of Building Materials and Components

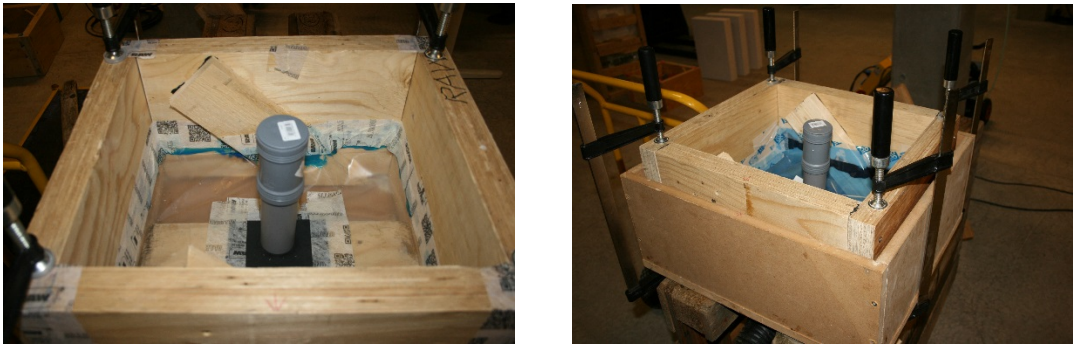
**Figure 3.** Test equipment for test of airtightness. Left: wooden frame with lining of membrane taped to the frame, pipe with collar in the middle. Right: wooden frame placed in box, a ventilator created a pressure difference between frame and box through a hole in the box (not visible on photo).

The test of airtightness was not a standard test but a test especially invented to simulate conditions in an older attic where it would be difficult to establish an airtight barrier. The aim was to test airtightness before and after artificial aging. The method is described in (Møller and Hansen, 2017). In short, it consisted of a wooden frame supplied with angled boards and a pipe in the middle. The inside of the frame was lined with the membrane to be tested and fixed to the frame with the system's tape. To secure airtightness around the pipe the system's collars were used and the pipe sealed. The frame was placed in a box leaving a small space between membrane and box, see Figure 3. It was ensured that the frame was airtight and so was the

connection between box and frame. Through a hole in the box a ventilator created a pressure difference between box and frame. The flow necessary to obtain pressurisation of 10, 22, 34, 46, 58, 70 and 82 Pa was recorded. The test was repeated three times and again three times with the same negative pressure differences. By linear regression, the results from the different pressure differences were combined to a single value for a pressurisation of 50 Pa. The test was inspired by the blower door test (EN/ISO 9972: 2015). After 164 days of artificial aging, the tests were repeated. One frame of each system was tested.

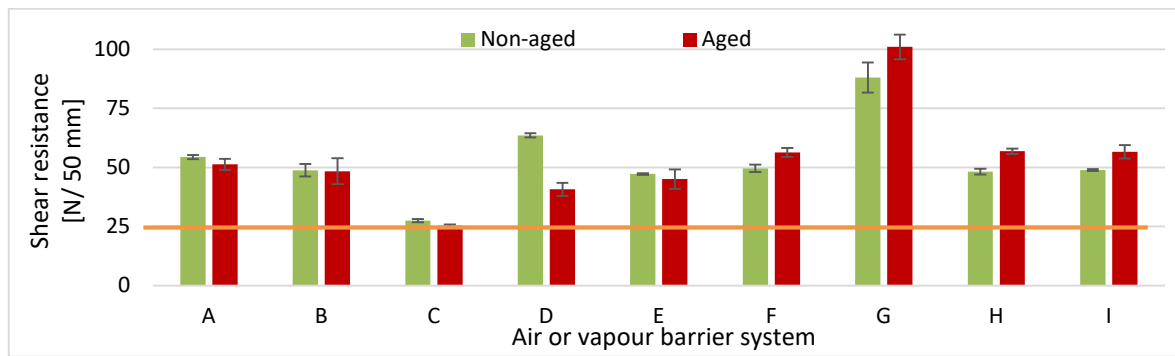
Figure 6. Shear strength, average of 5 samples with standard deviations. Orange line: DUKO requirements for non-aged and aged joints.

The results of the shear tests are shown in Figure 6, all systems fulfilled the DUKO requirements. The non-aged samples of system A did not come apart; the membrane, however, was stretched to more than the double of its length, without enhancing the force of the machine. In the rest of the systems, the adhesive did not stick to the tape. In the aged samples, the tape broke in system A and G, in the other systems the adhesive did not stick to the tape.
